## Insulation resistance tests

## Photo/Drawing with Values

| Date | Time | Title |
|---|---|---|
| 2018-11-13 | 14:08:15 | Switchboard |

| Measurement Location | Measured by | Witnessed by |
|---|---|---|
| 動力盤 3 | | |

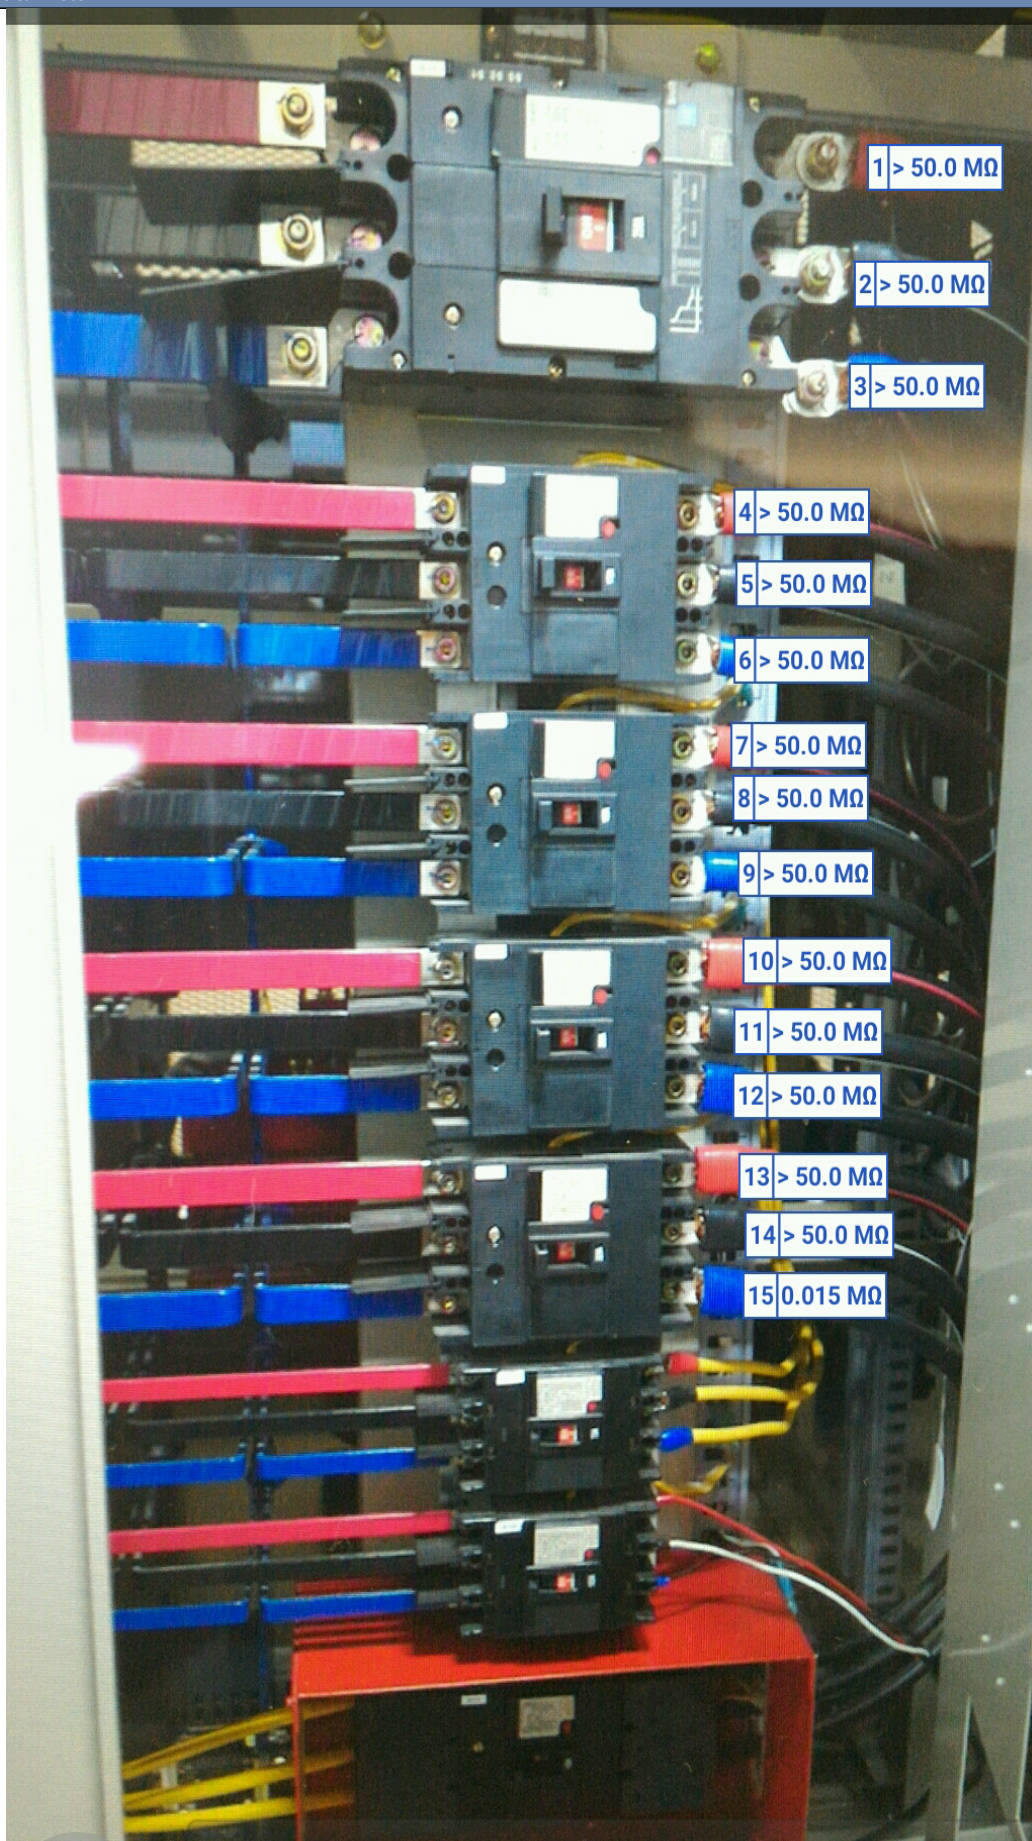
Measured Value/Photo

| No. | Date | Time | Measured value | | Function | Mode | Status | Filter | Instrument Name | Comment |
|---|---|---|---|---|---|---|---|---|---|---|
| 15 | 2018-11-13 | 14:07:43 | 0.015 | MΩ | | | 250V RANGE | | IR4054#000000015 | |
